New Bedford Harbor Superfund Site

OSRR Briefing - 5/08/08

- I. Background/progress to date
- II. Pilot underwater cap
- III. CAD cell alternative

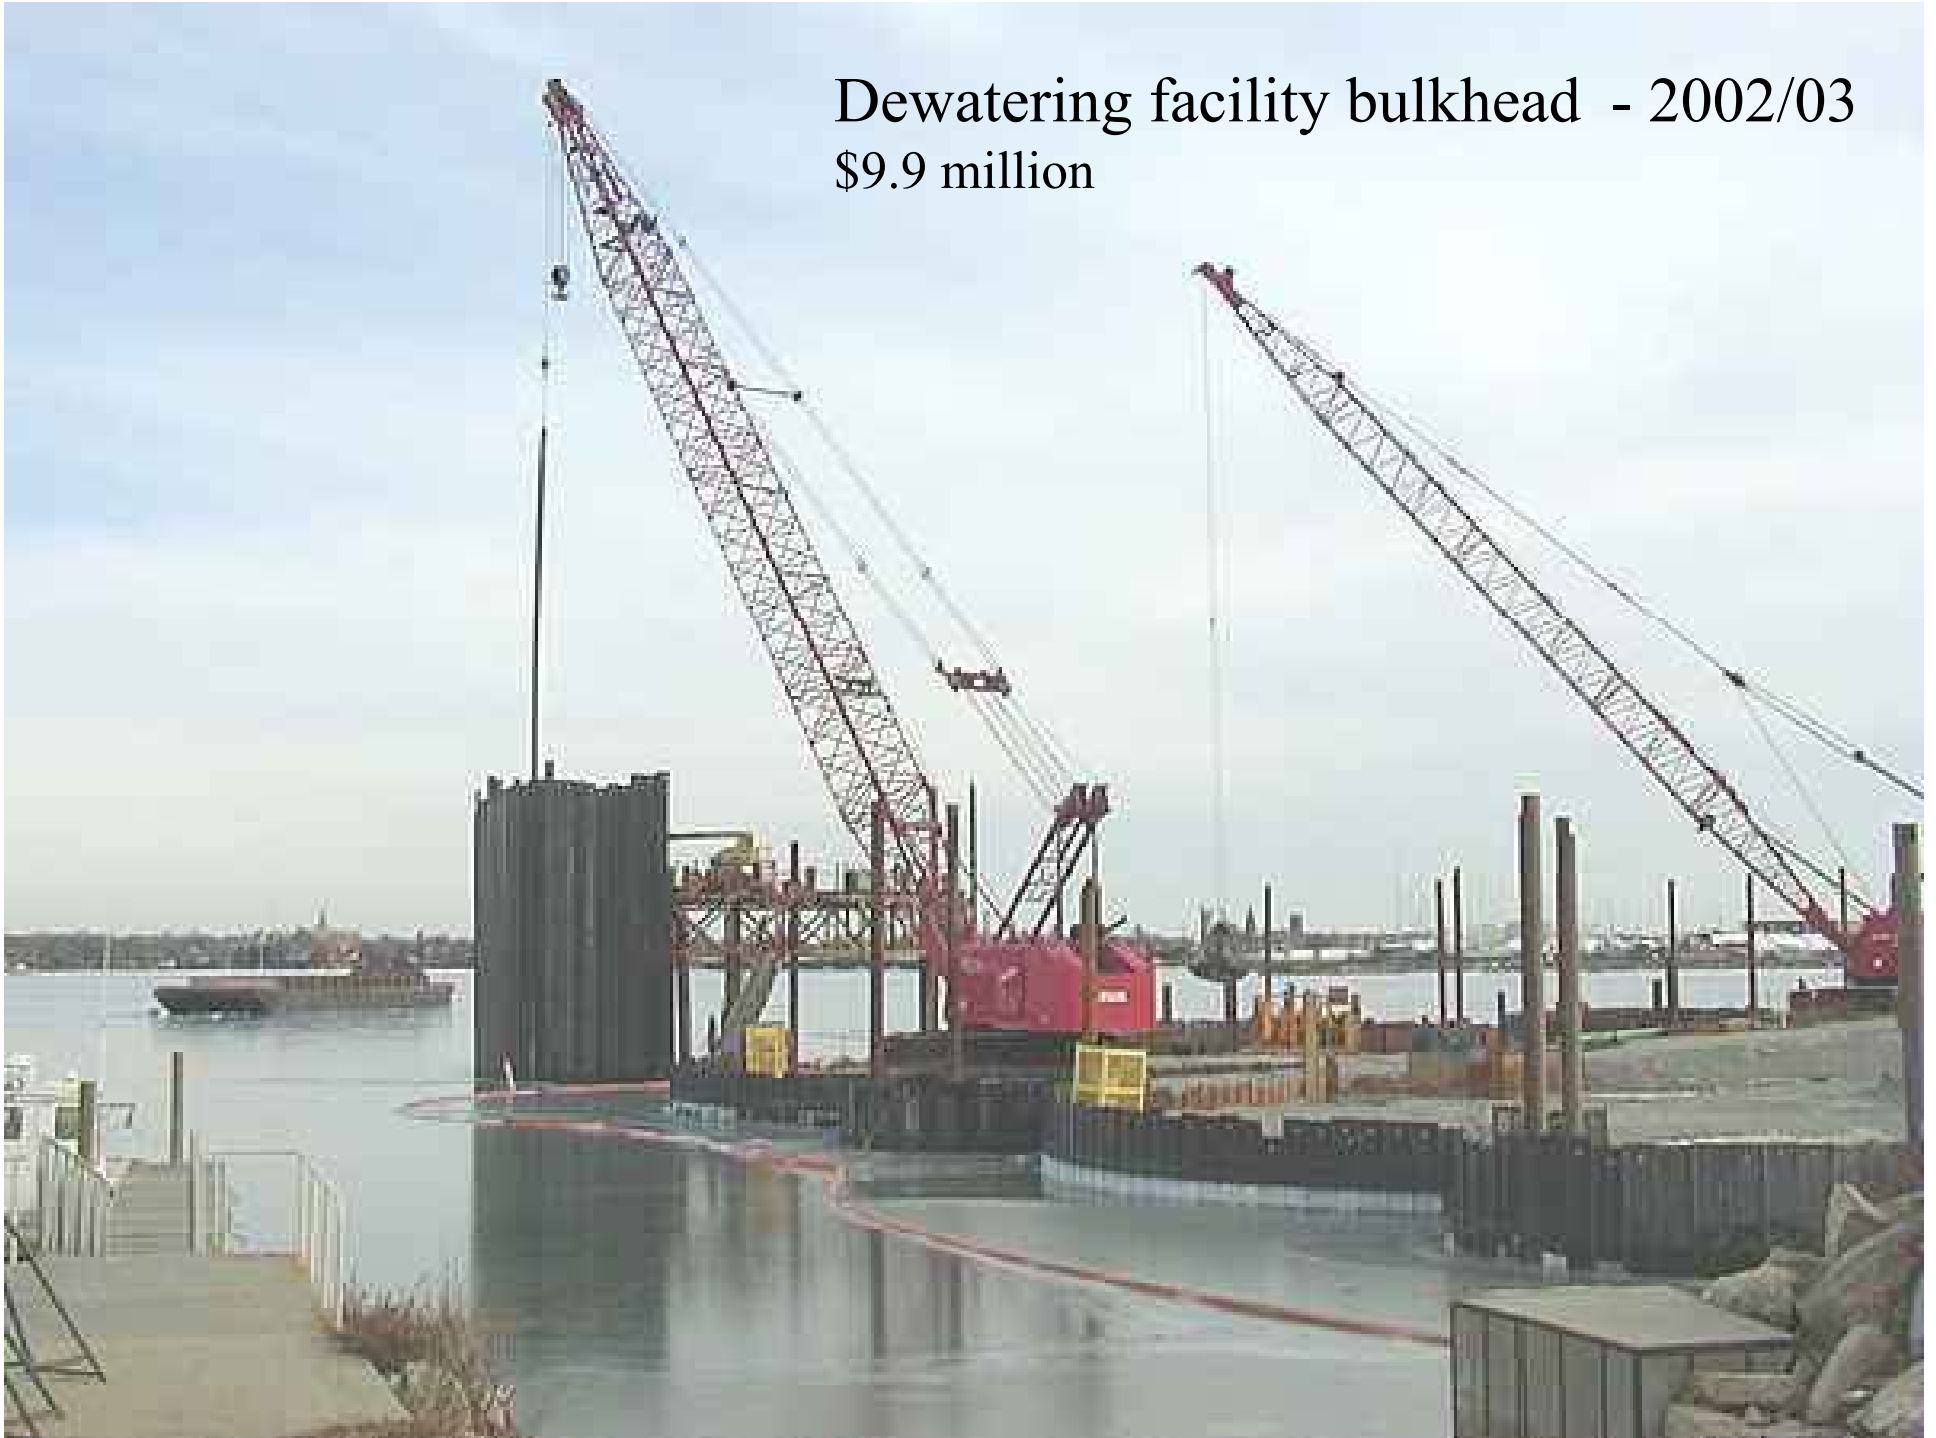
Dewatering facility bulkhead - 2002/03
\$9.9 million

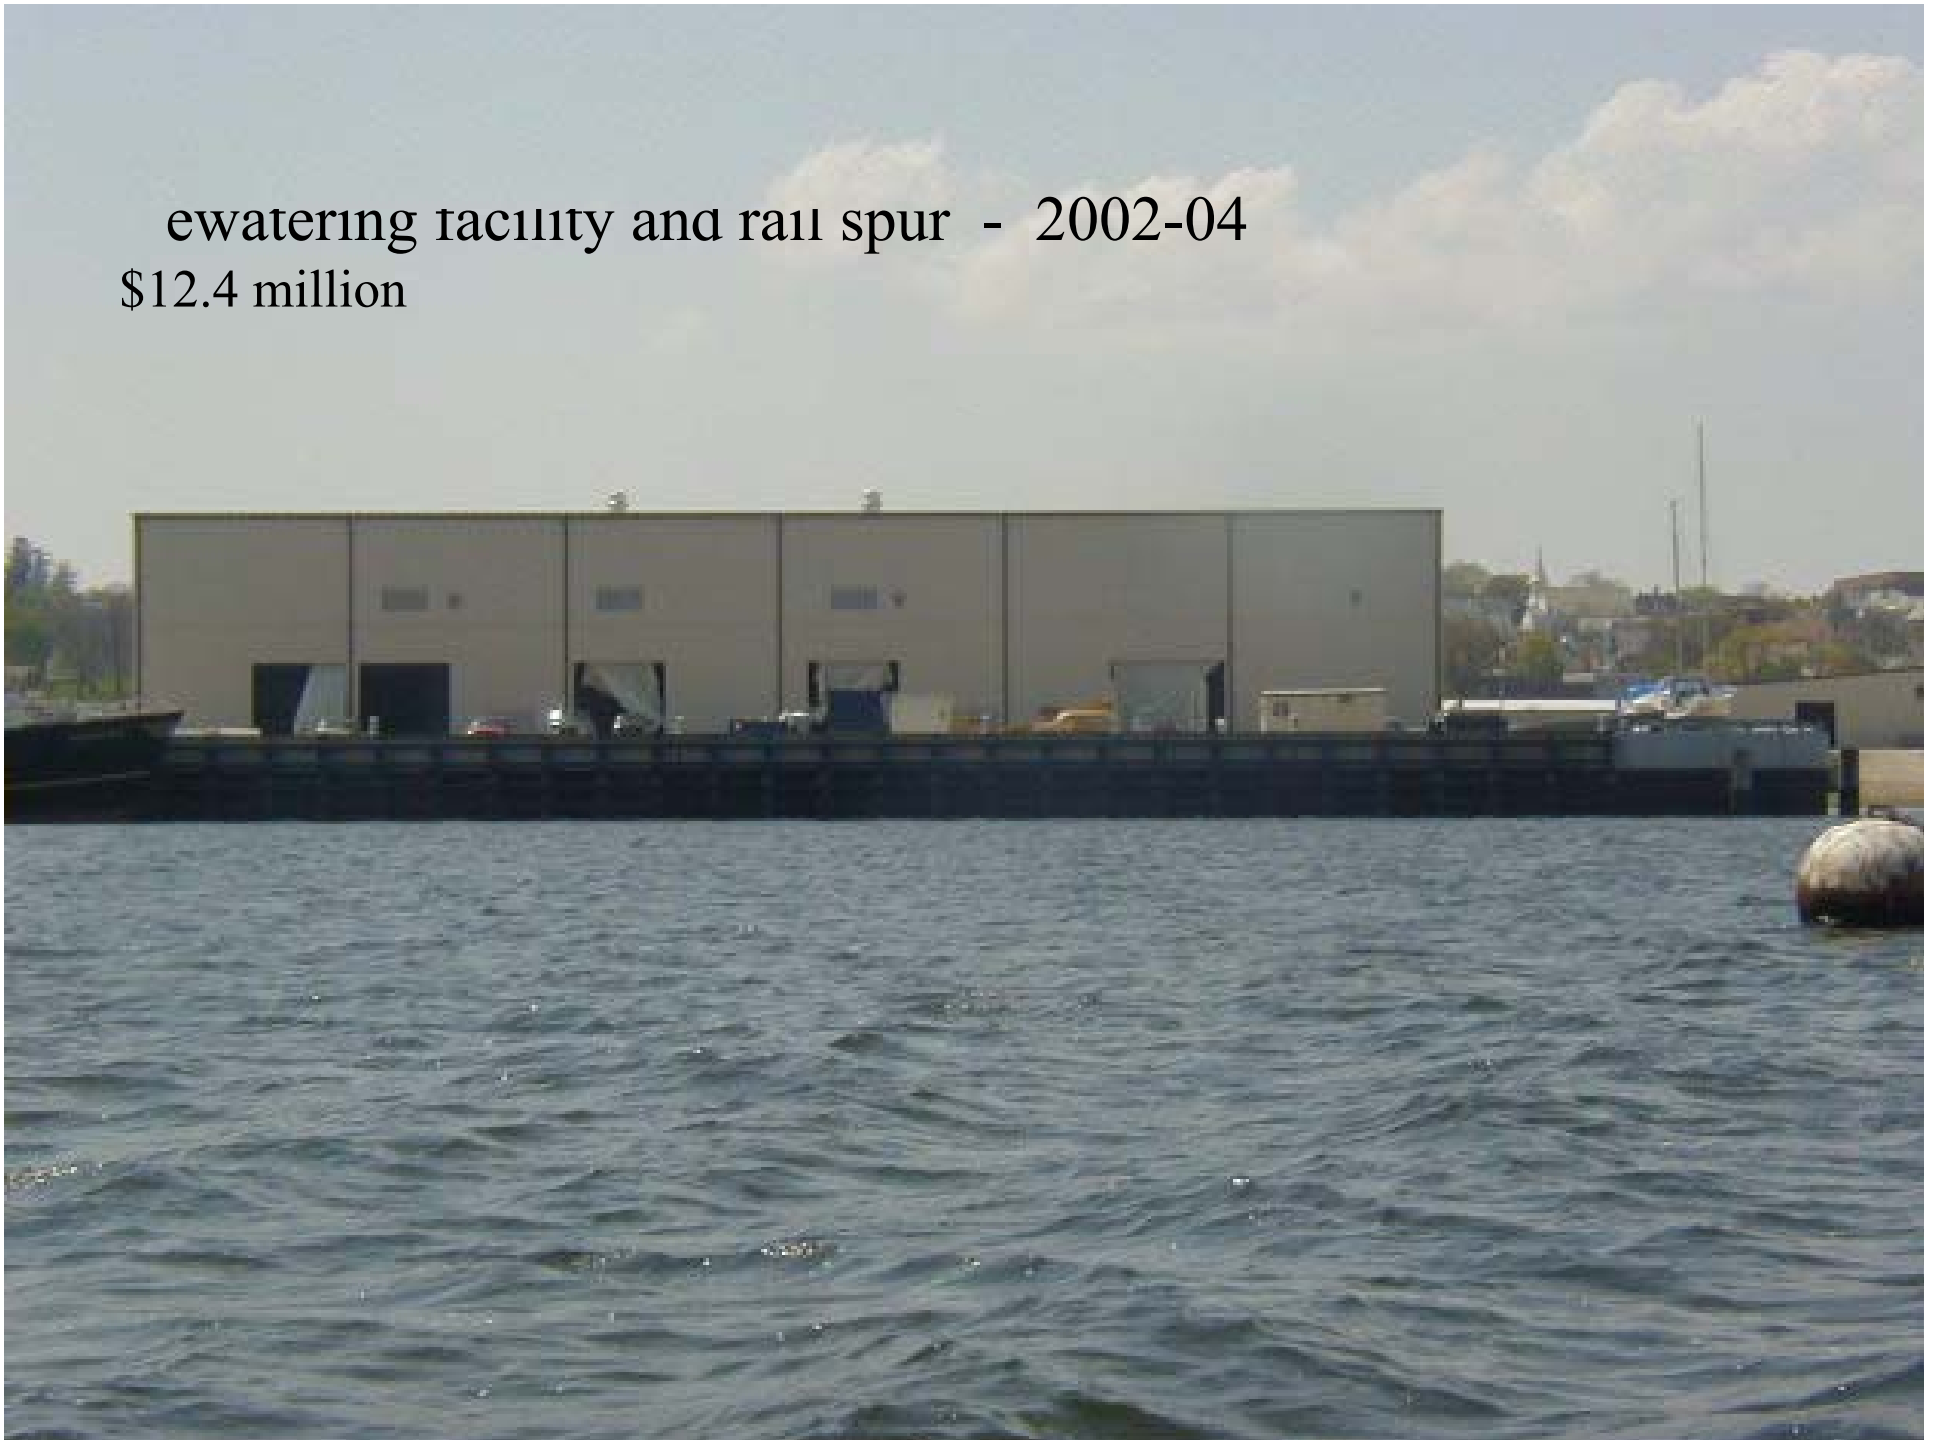
ewatering facility and rail spur - 2002-04
\$12.4 million

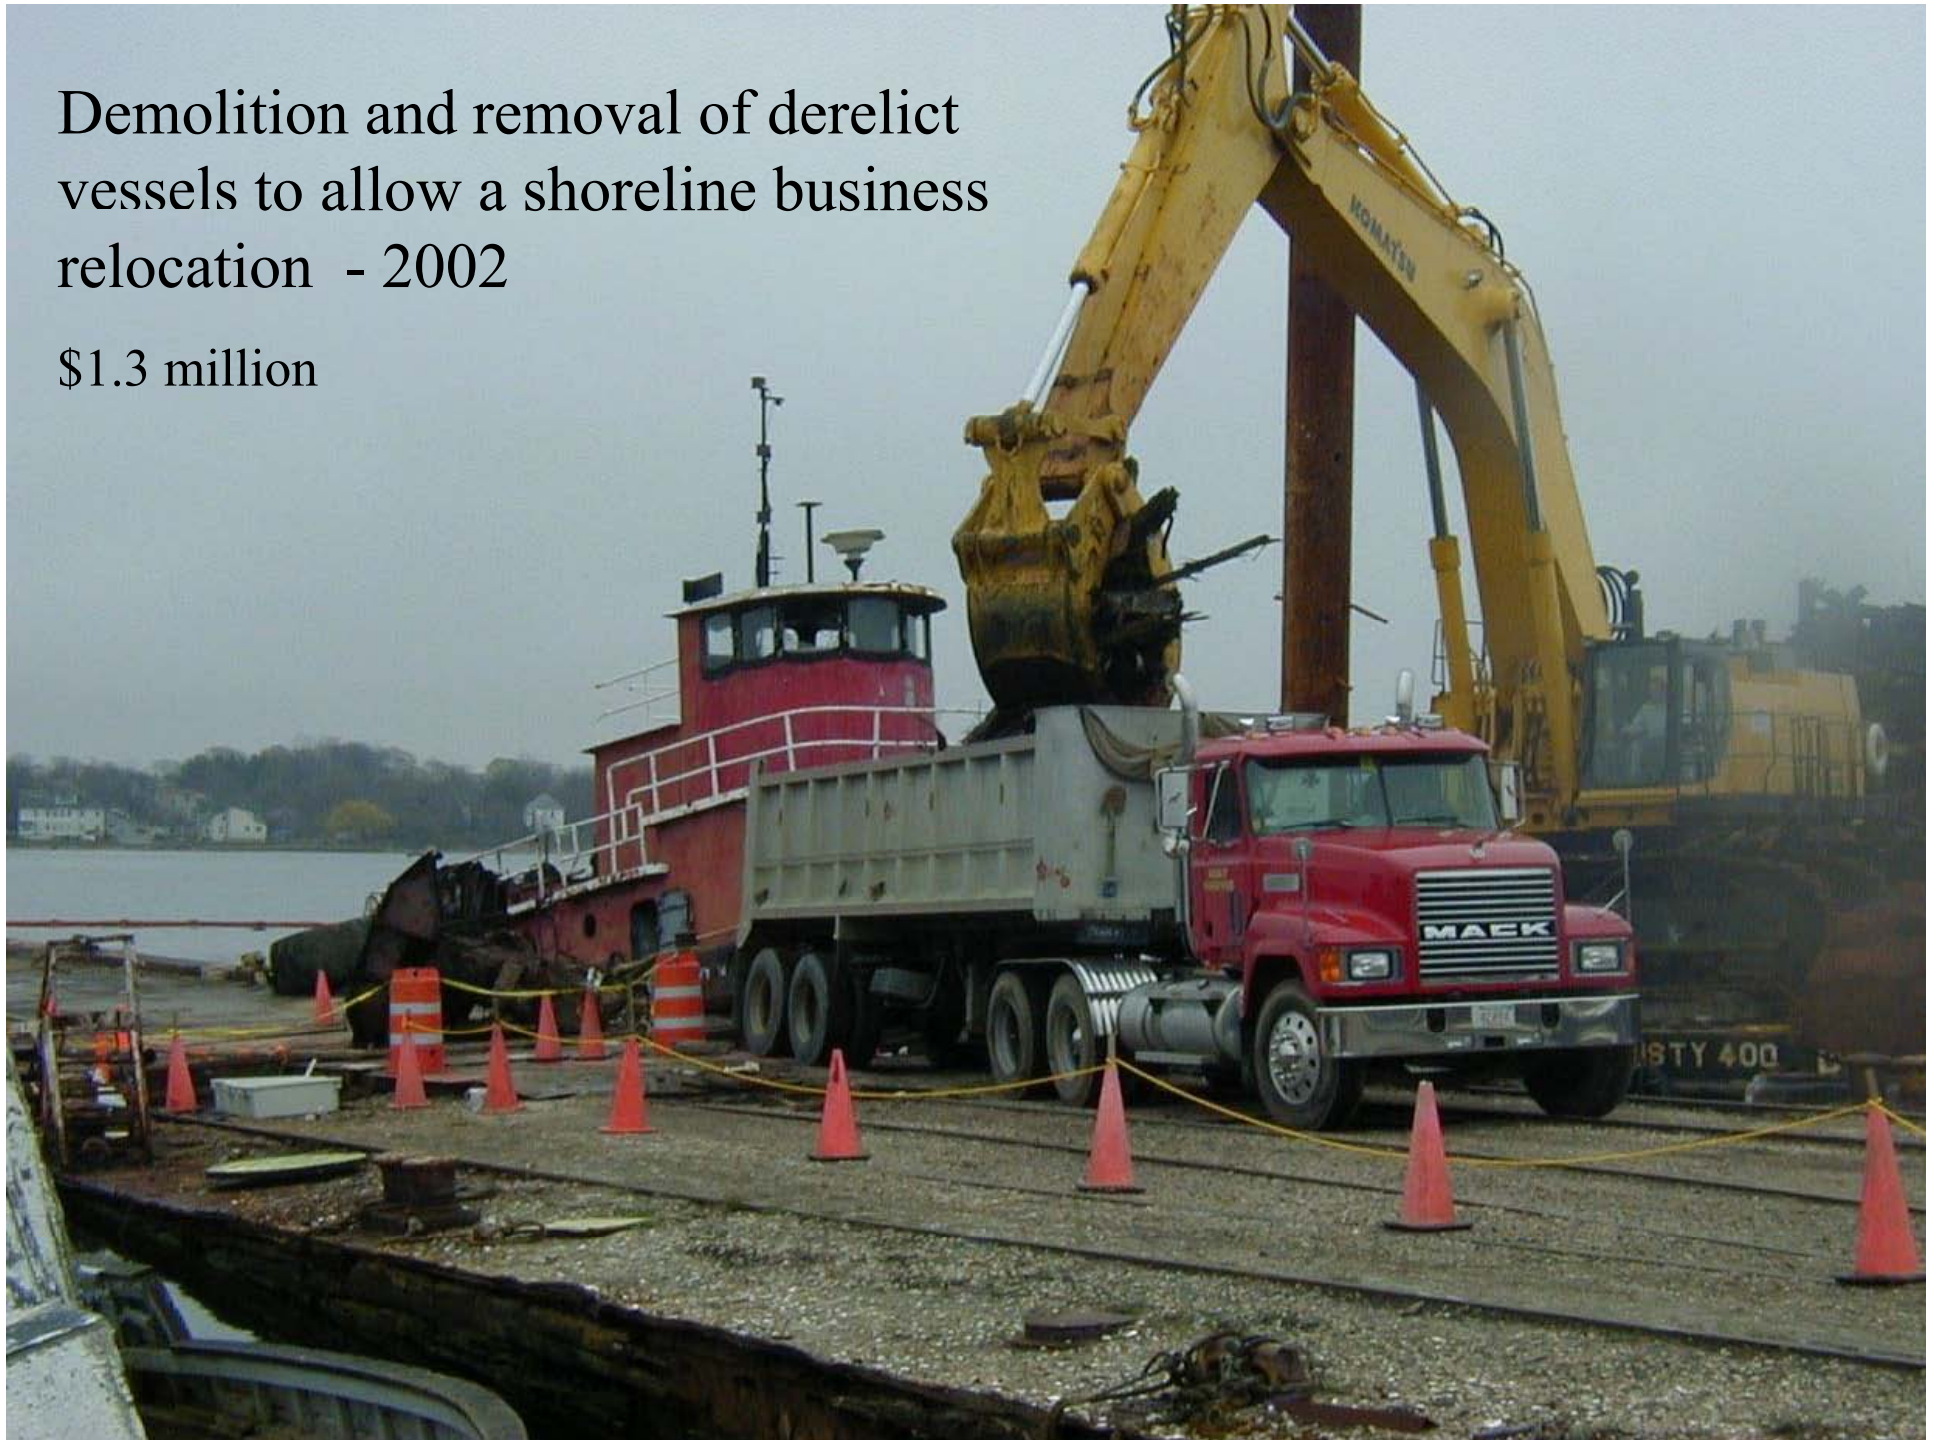
Demolition and removal of derelict
vessels to allow a shoreline business
relocation - 2002

\$1.3 million

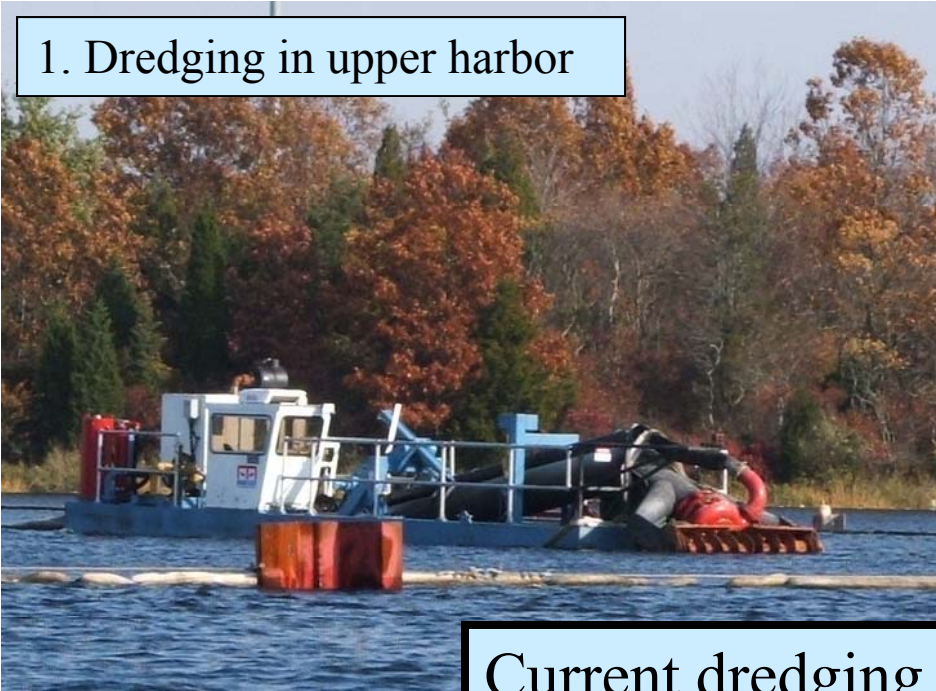
1. Dredging in upper harbor

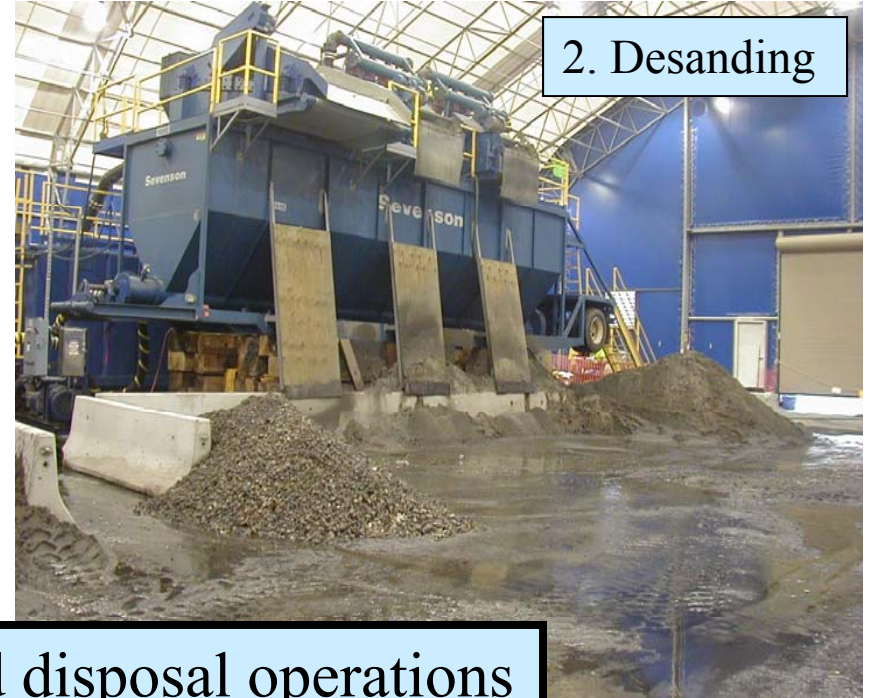
2. Desanding

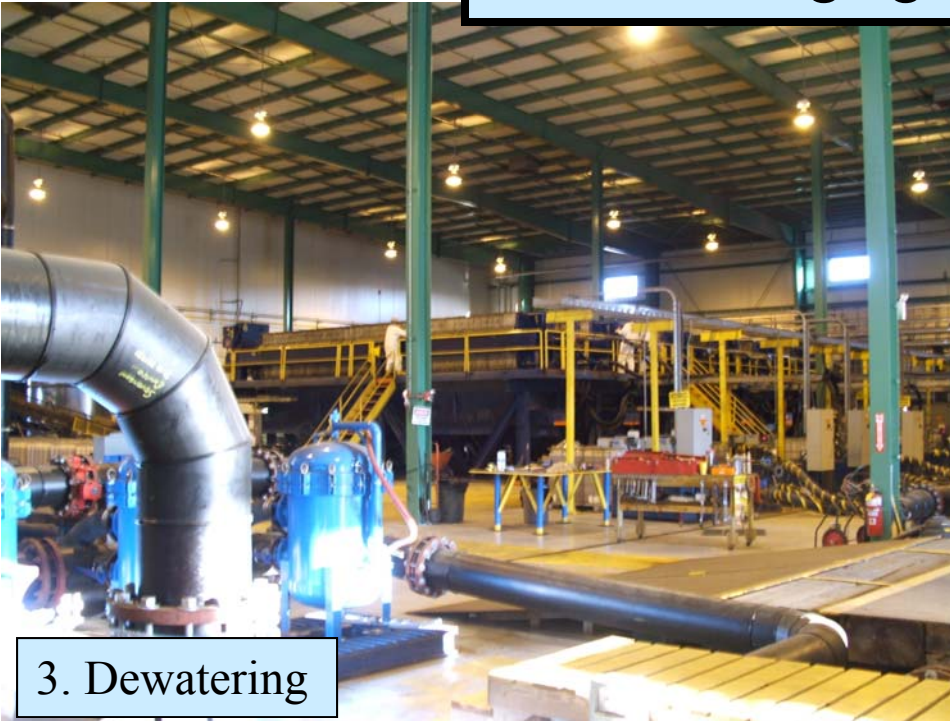
3. Dewatering

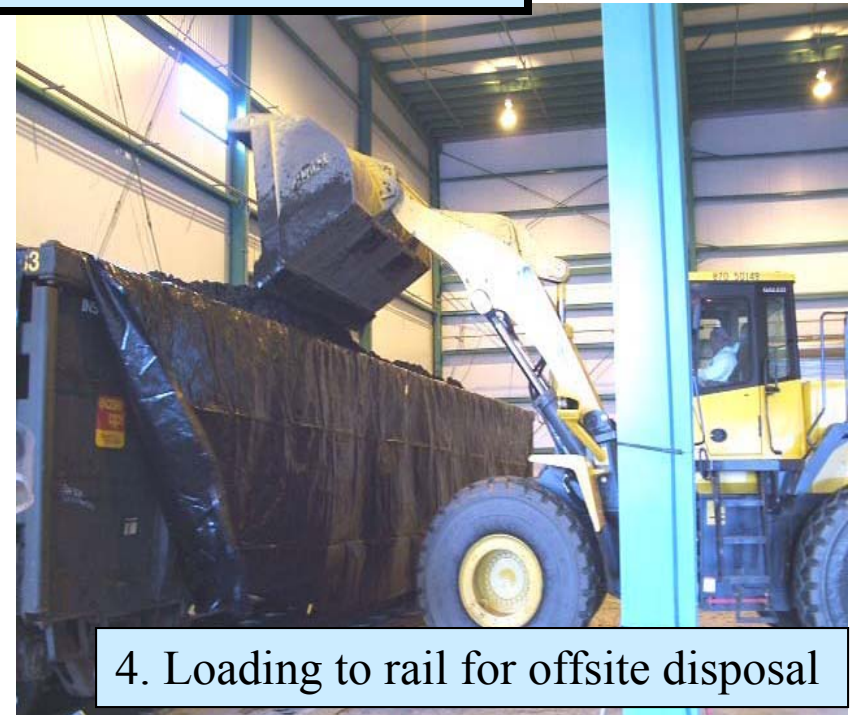
4. Loading to rail for offsite disposal

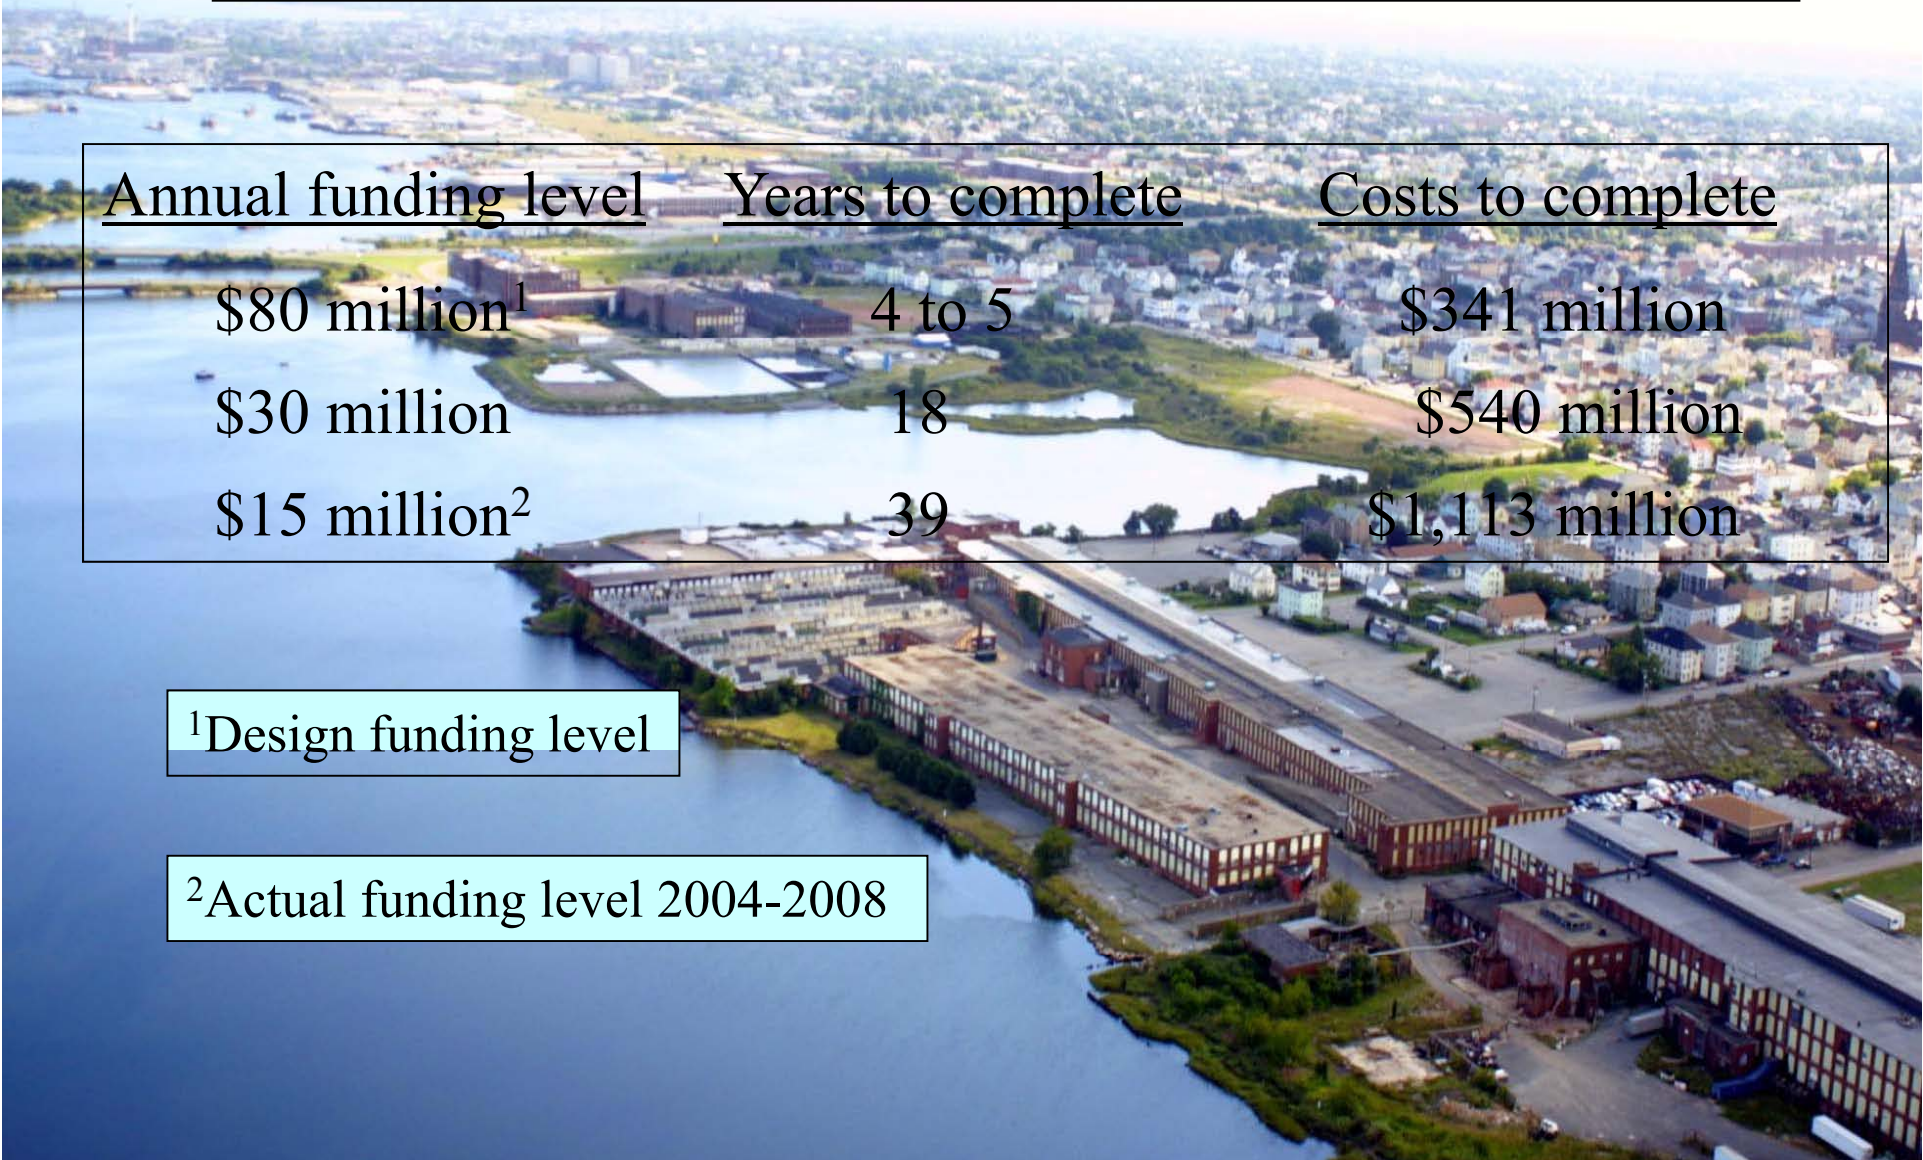
Cost and Schedule Estimate for Current Approach

3.5% annual inflation assumed

<u>Annual funding level</u>	<u>Years to complete</u>	<u>Costs to complete</u>
\$80 million ¹	4 to 5	\$341 million
\$30 million	18	\$540 million
\$15 million ²	39	\$1,113 million

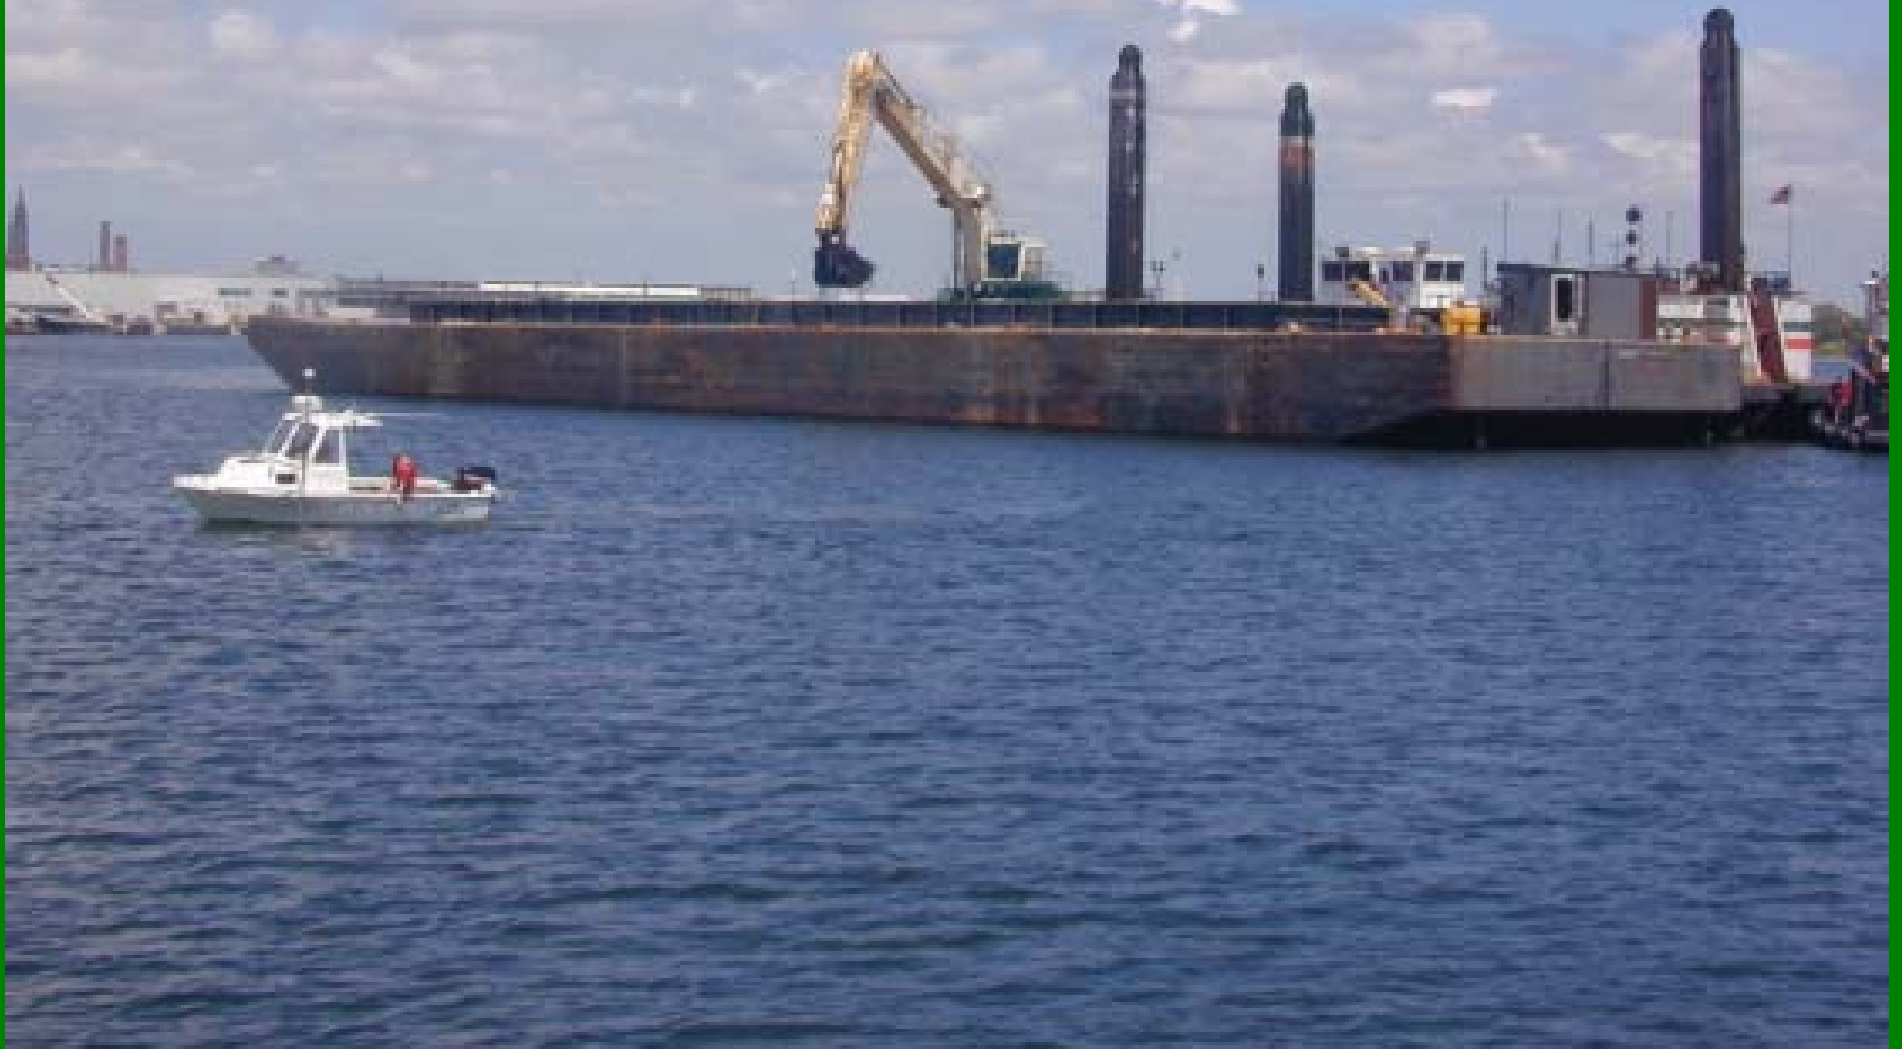
The port's CAD cell being excavated

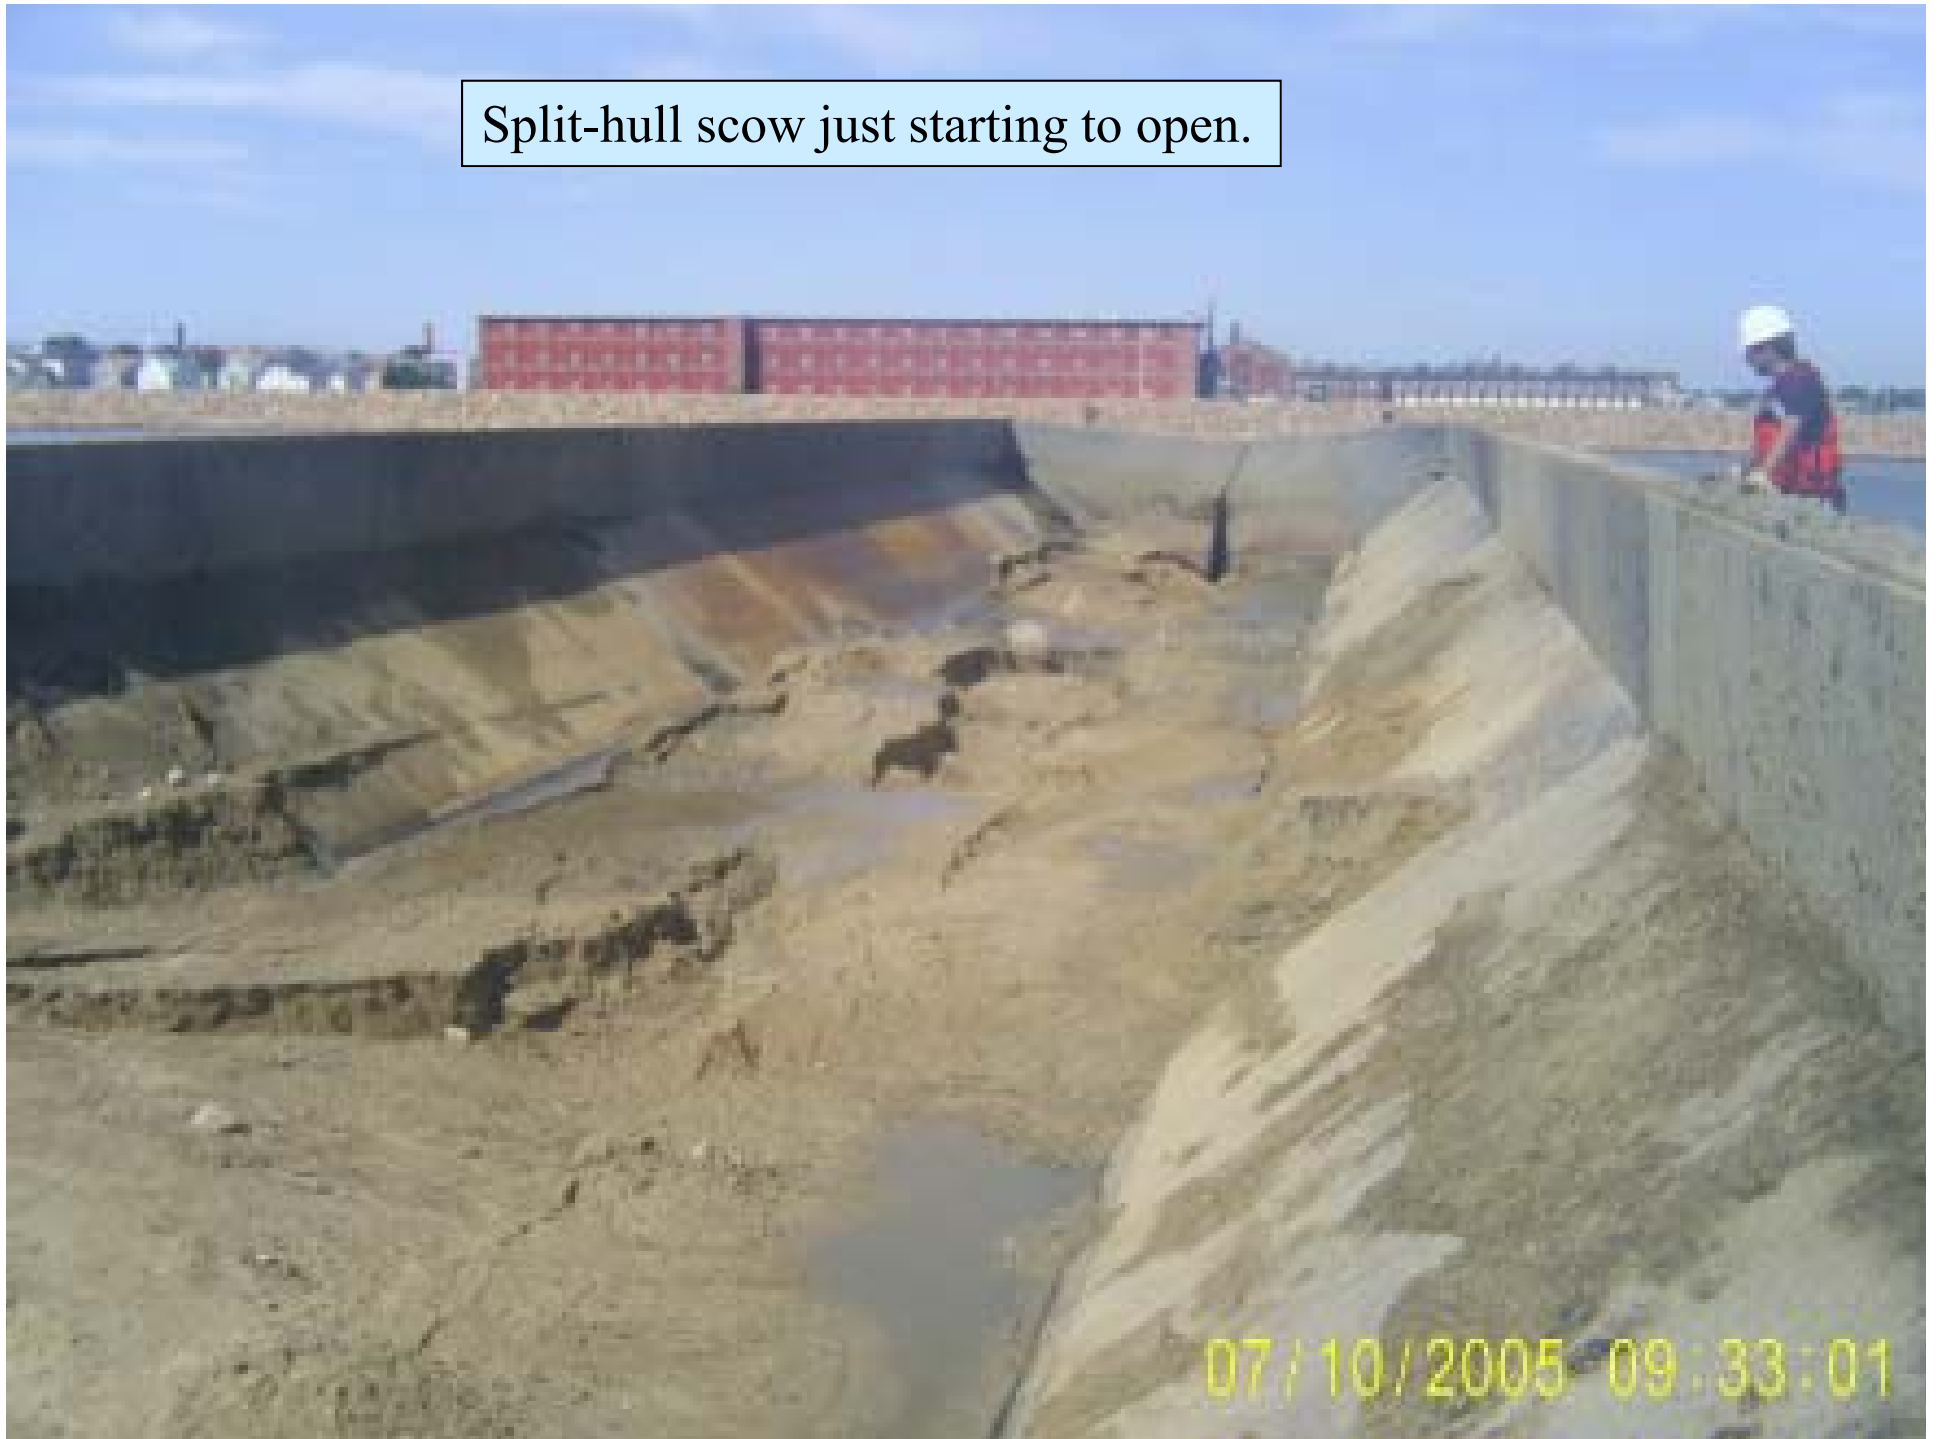
Split-hull scow just starting to open.

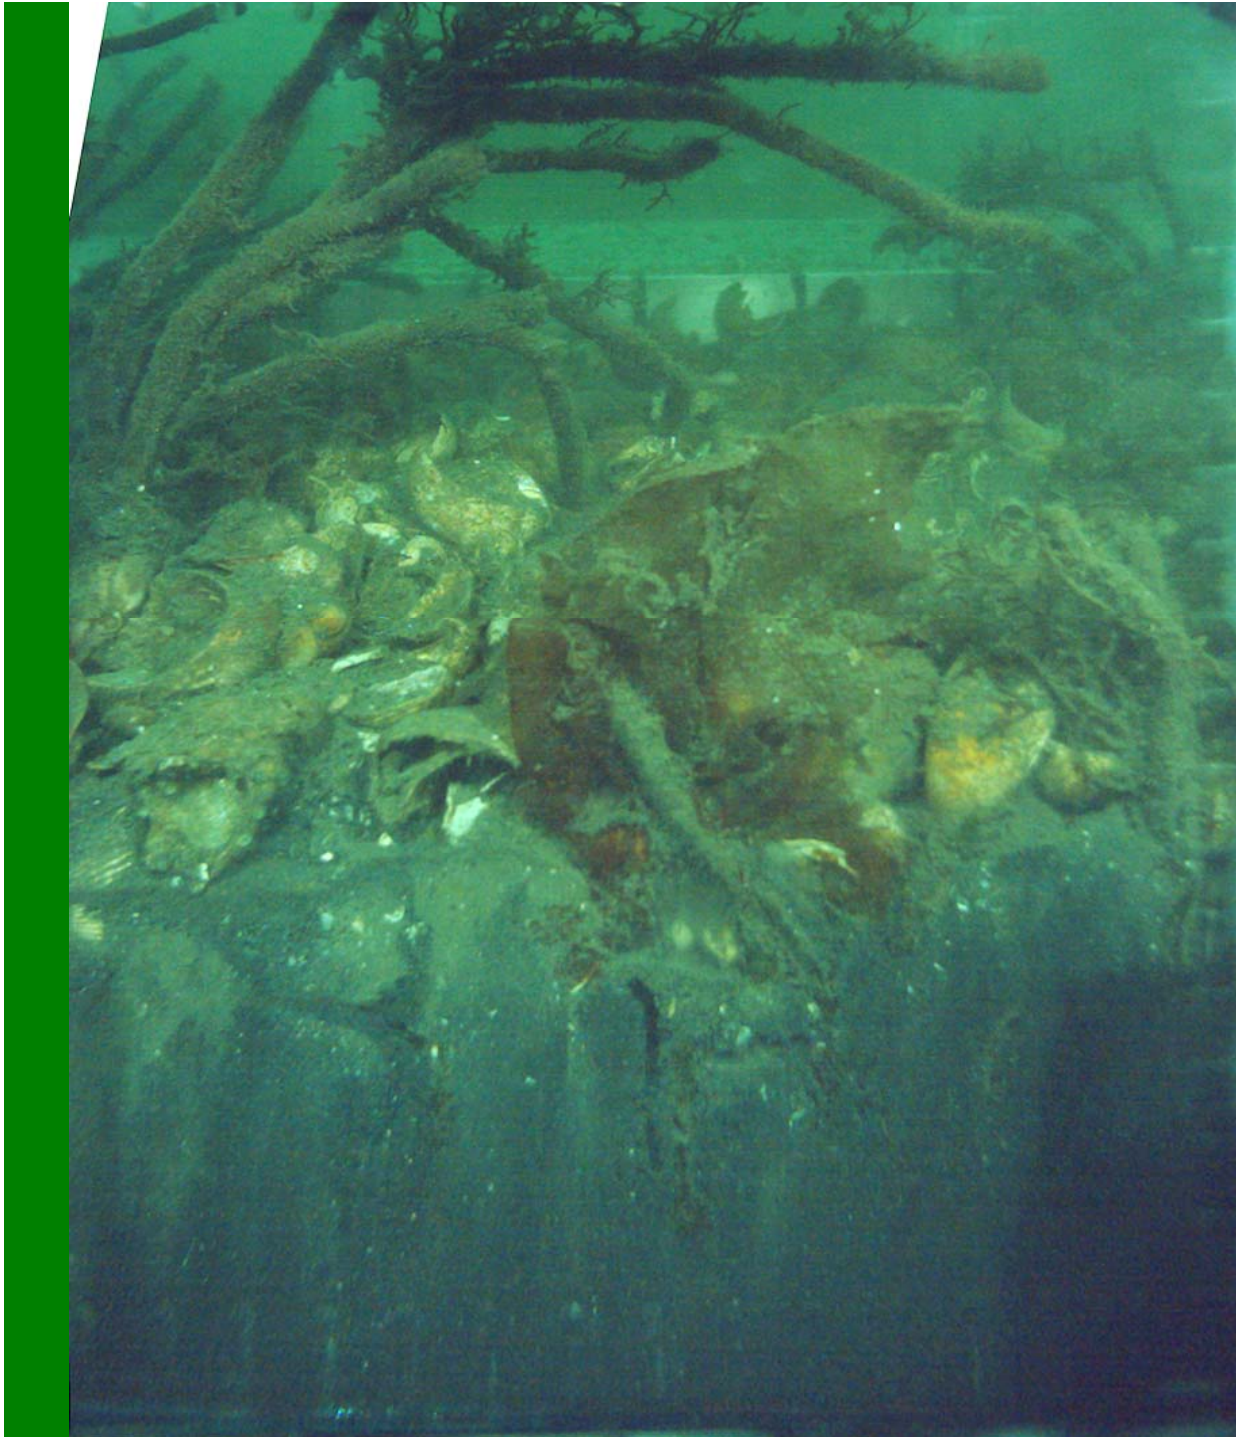
★ = 17
post-cap
sediment
sampling
locations
